FINAL REPORT ON

INITIAL PRODUCTION TEST

MARGINAL TERRAIN ASSAULT BRIDGE

WITH APC LAUNCHER

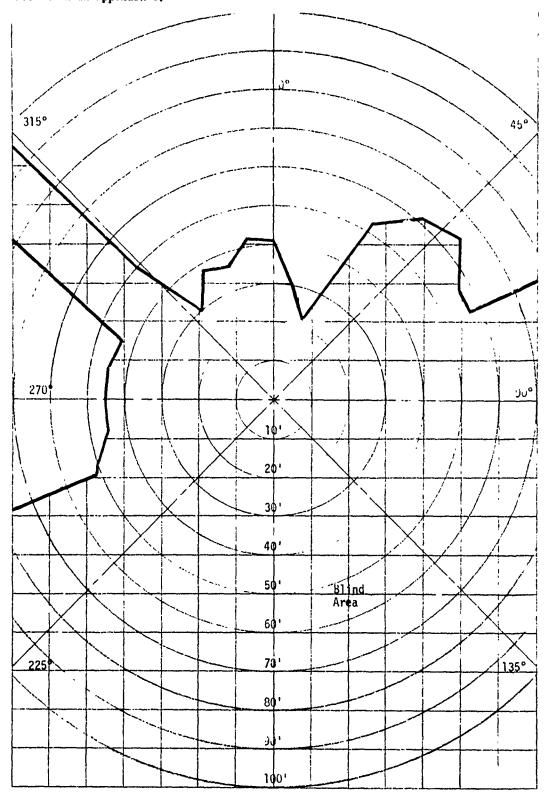
Figure 2.14-I: Limits of Vision, Driver's Station.

When the bridge is resting on the ground, the guide pins and rear end of the bridge extend 86 and 32 inches, respectively, to the front of the vehicle. Therefore, neither the driver nor the bridge operator can see these points when coupling or uncoupling the bridge.

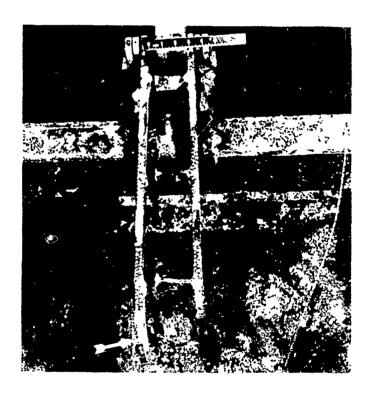
Figure I-22: Failed Connection to Link Beam (White Arrow) and Failed Welds at Crosspieces (Black Arrows). Odom. Odom. 856, 320 Launches.

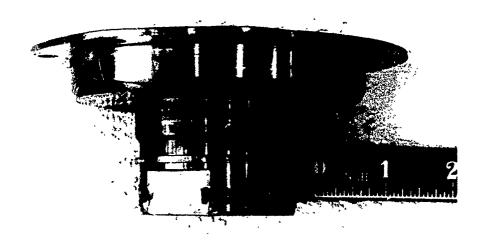
Figure I-24: Damaged Seal Area on Transmission Front Pump Housing. 441 Launches, 1070 Miles.

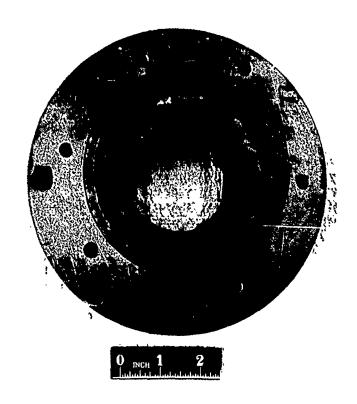
Figure I-25: Damaged Front Pump in Transmission. 441 Launches, 1070 Miles.
